4.3 KENNEDY CREEK SIPHON

4.3.1 Structure Overview

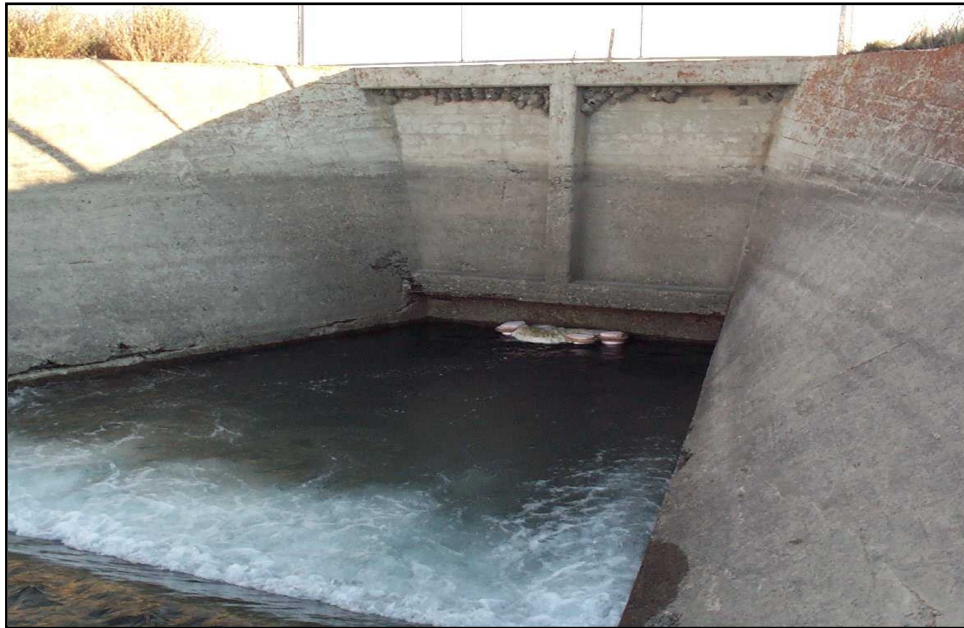
The inlet to the siphon appears to be in generally poor to marginal condition (Figure 4.3.1). There are areas of deteriorated concrete with pockets and holes near the winter low water line. Some reinforcing steel is exposed. The headwall is cracked in several places (Figure 4.3.2).

Figure 4.3.1 Inlet section (south side) of Kennedy Creek Siphon (10/13/04).

The headwalls on either end of the siphon have some severe cracks with exposed reinforcing steel. The concrete inlet and outlet sections have deteriorated concrete at the winter water line. In general, this structure appears to be repairable. However, the cost difference of a replacement structure and the ability to perform summer construction make structure replacement the prudent alternative. Also, the hydraulic capacity of this siphon needs to be analyzed to determine if it is compatible with the various proposed design flows for the canal (>850 cfs). If inadequate, a parallel and larger replacement siphon is definitely warranted.

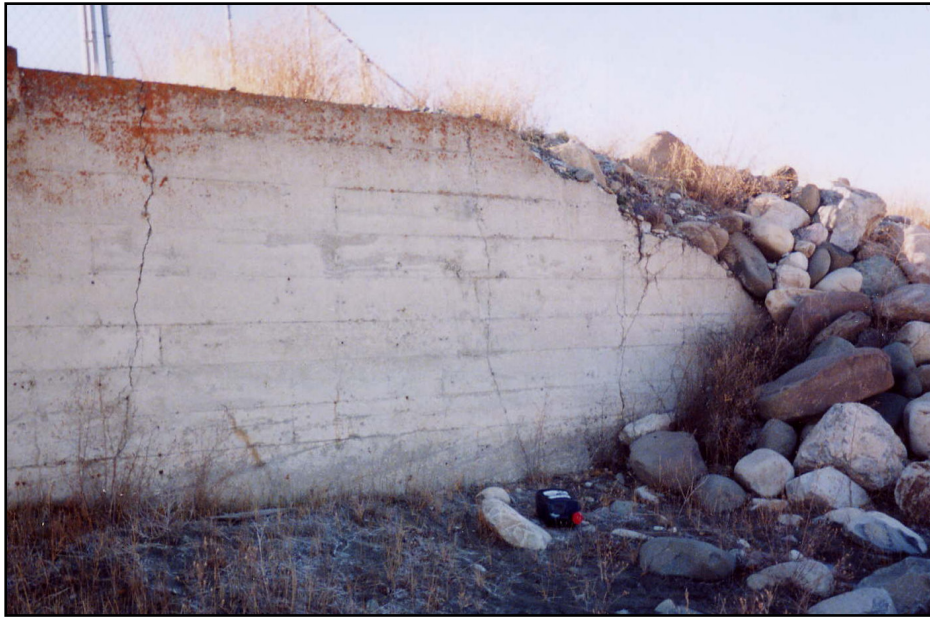
Figure 4.3.2 Kennedy Creek side of inlet structure (11/11/04).

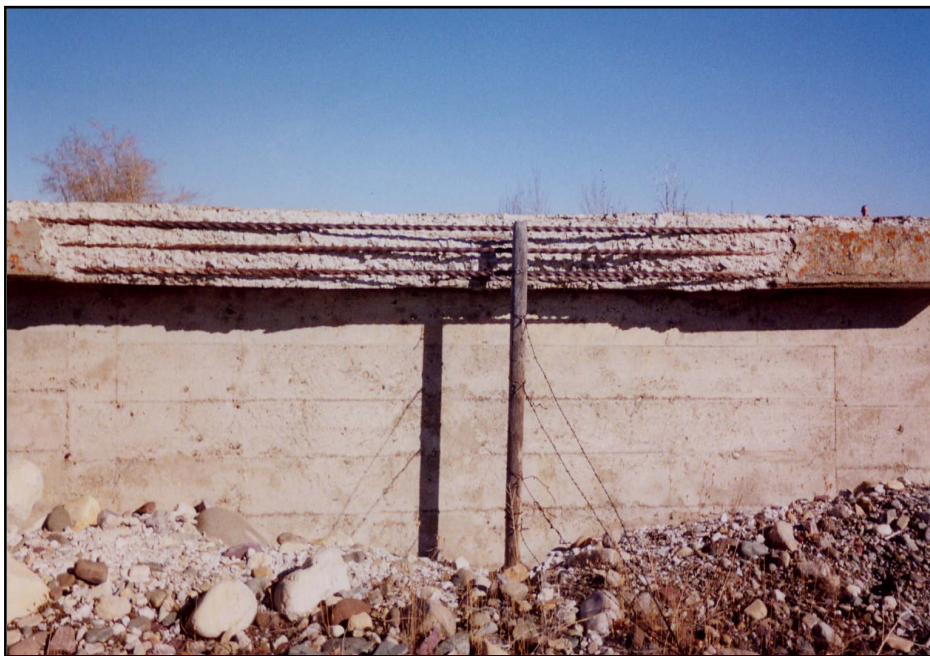
The outlet of the siphon is in similarly poor condition as the inlet. The beam at the top of the retaining wall at the siphon exit is in poor condition with a large amount of spalling and reinforcing steel exposed (Figure 4.3.3). The retaining walls appear to have been extended since the original construction based on the appearance of joints and types of exposed rebar.

Figure 4.3.3 Kennedy Creek side of outlet structure (11/11/04).
